**FINAL REPORT  
FOR  
TF30 THIRD-STAGE COMPOSITE FAN BLADE  
SERVICE PROGRAM  
Contract No. F33657-70-C-0624**

David G. Randall  
Pratt & Whitney Aircraft Group  
United Technologies Corporation  
East Hartford, Connecticut 06108

15 May 1978

Final Report for Period 1 July 1970 – 31 December 1977

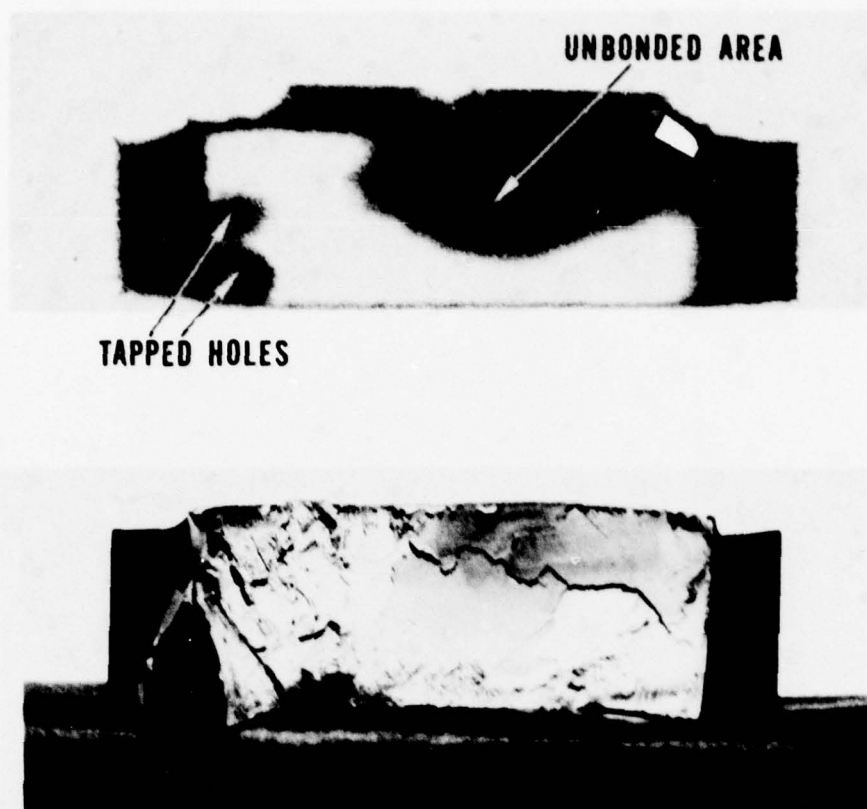
Figure B-4      *Example of Root Bond Defect Readily Detected By C-Scan Inspection*
